## OFFwind Highlights No. 2 – MAY 2024

### SEA ICE STUDIES

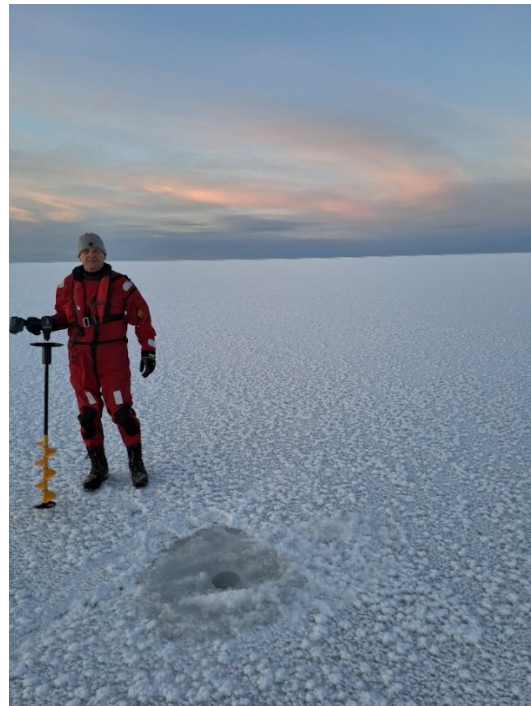
*Picture 1. Ice measurement 8.1.2024*

The initial sea ice measurement took place on January 8, 2024. Preceding the expedition, there had been an exceptionally cold two-week period, with temperatures plummeting to -30 degrees Celsius. A hydrocopter was deployed to access the ice. The measurement plan involved traversing a line from the shoreline out to the Windmill area. Starting near the coastline, measurements were to be taken approximately every kilometer along the line until reaching open water.

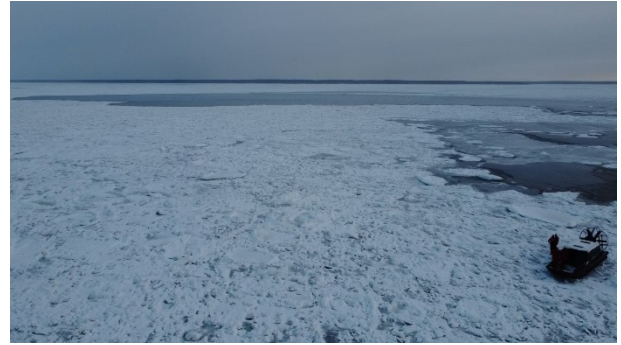
*Picture 3. Outside Harvungön 6.2.2024*

The second ice measurement expedition took place on 6.2.2024. In the weeks leading up to the expedition, we experienced weather with higher temperatures and strong winds from various directions. From the satellite images, it was difficult to determine the condition of the ice, so we decided to go out with a hydrocopter to assess the ice situation. When we approached the area where we conducted ice measurements during the first expedition, we found that the winds had broken up the ice, leaving a lot of ice floes standing on edge. We still attempted to venture further out to see if the ice might be smoother there, but when we reached Harvungön, we had to abort to avoid the risk of the hydrocopter breaking in the uneven ice. We observed some ice ridges with piled-up ice on shoals further inland. There is a video from the expedition filmed with drones available on the project's website. Picture 2 depicts the ice conditions outside Harvungön,

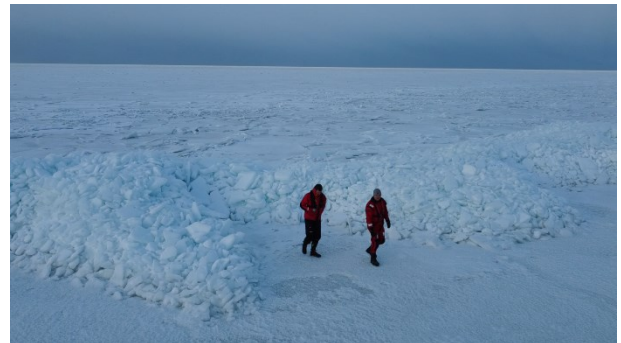
*Picture 4. Ice walls*

while Picture 3 showcases ice walls that have accumulated along the shoreline.
